# Creosote Contamination From Two Former Wood Preserving Facilities

From the Old Industrial Area  
Of Prince Albert, SK

15<sup>th</sup> Street - 6<sup>th</sup> to 13<sup>th</sup> Avenues East

Prepared By: Saskatchewan Environment  
Environmental Protection Branch

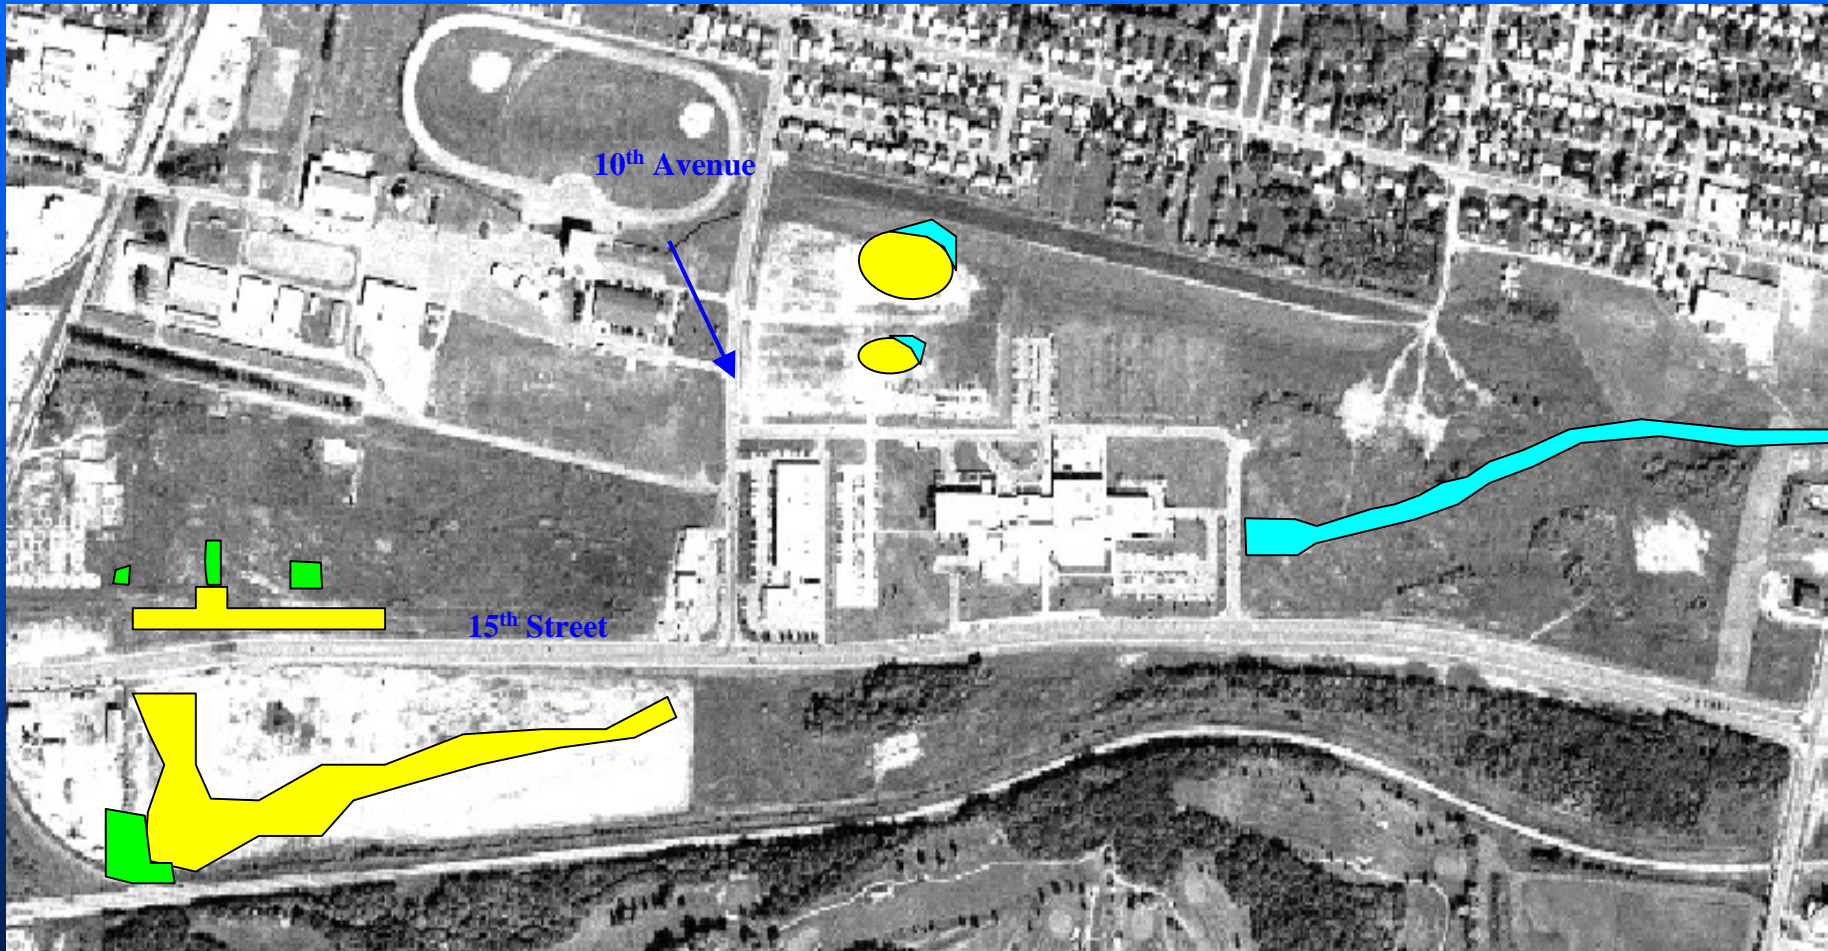
# Multiple Clean-ups

1994 Clean up - (SFP, City of PA, CN Rail)

City of PA Clean up - 1999 – 2000

Centenary Fund Clean up - 2001-2004

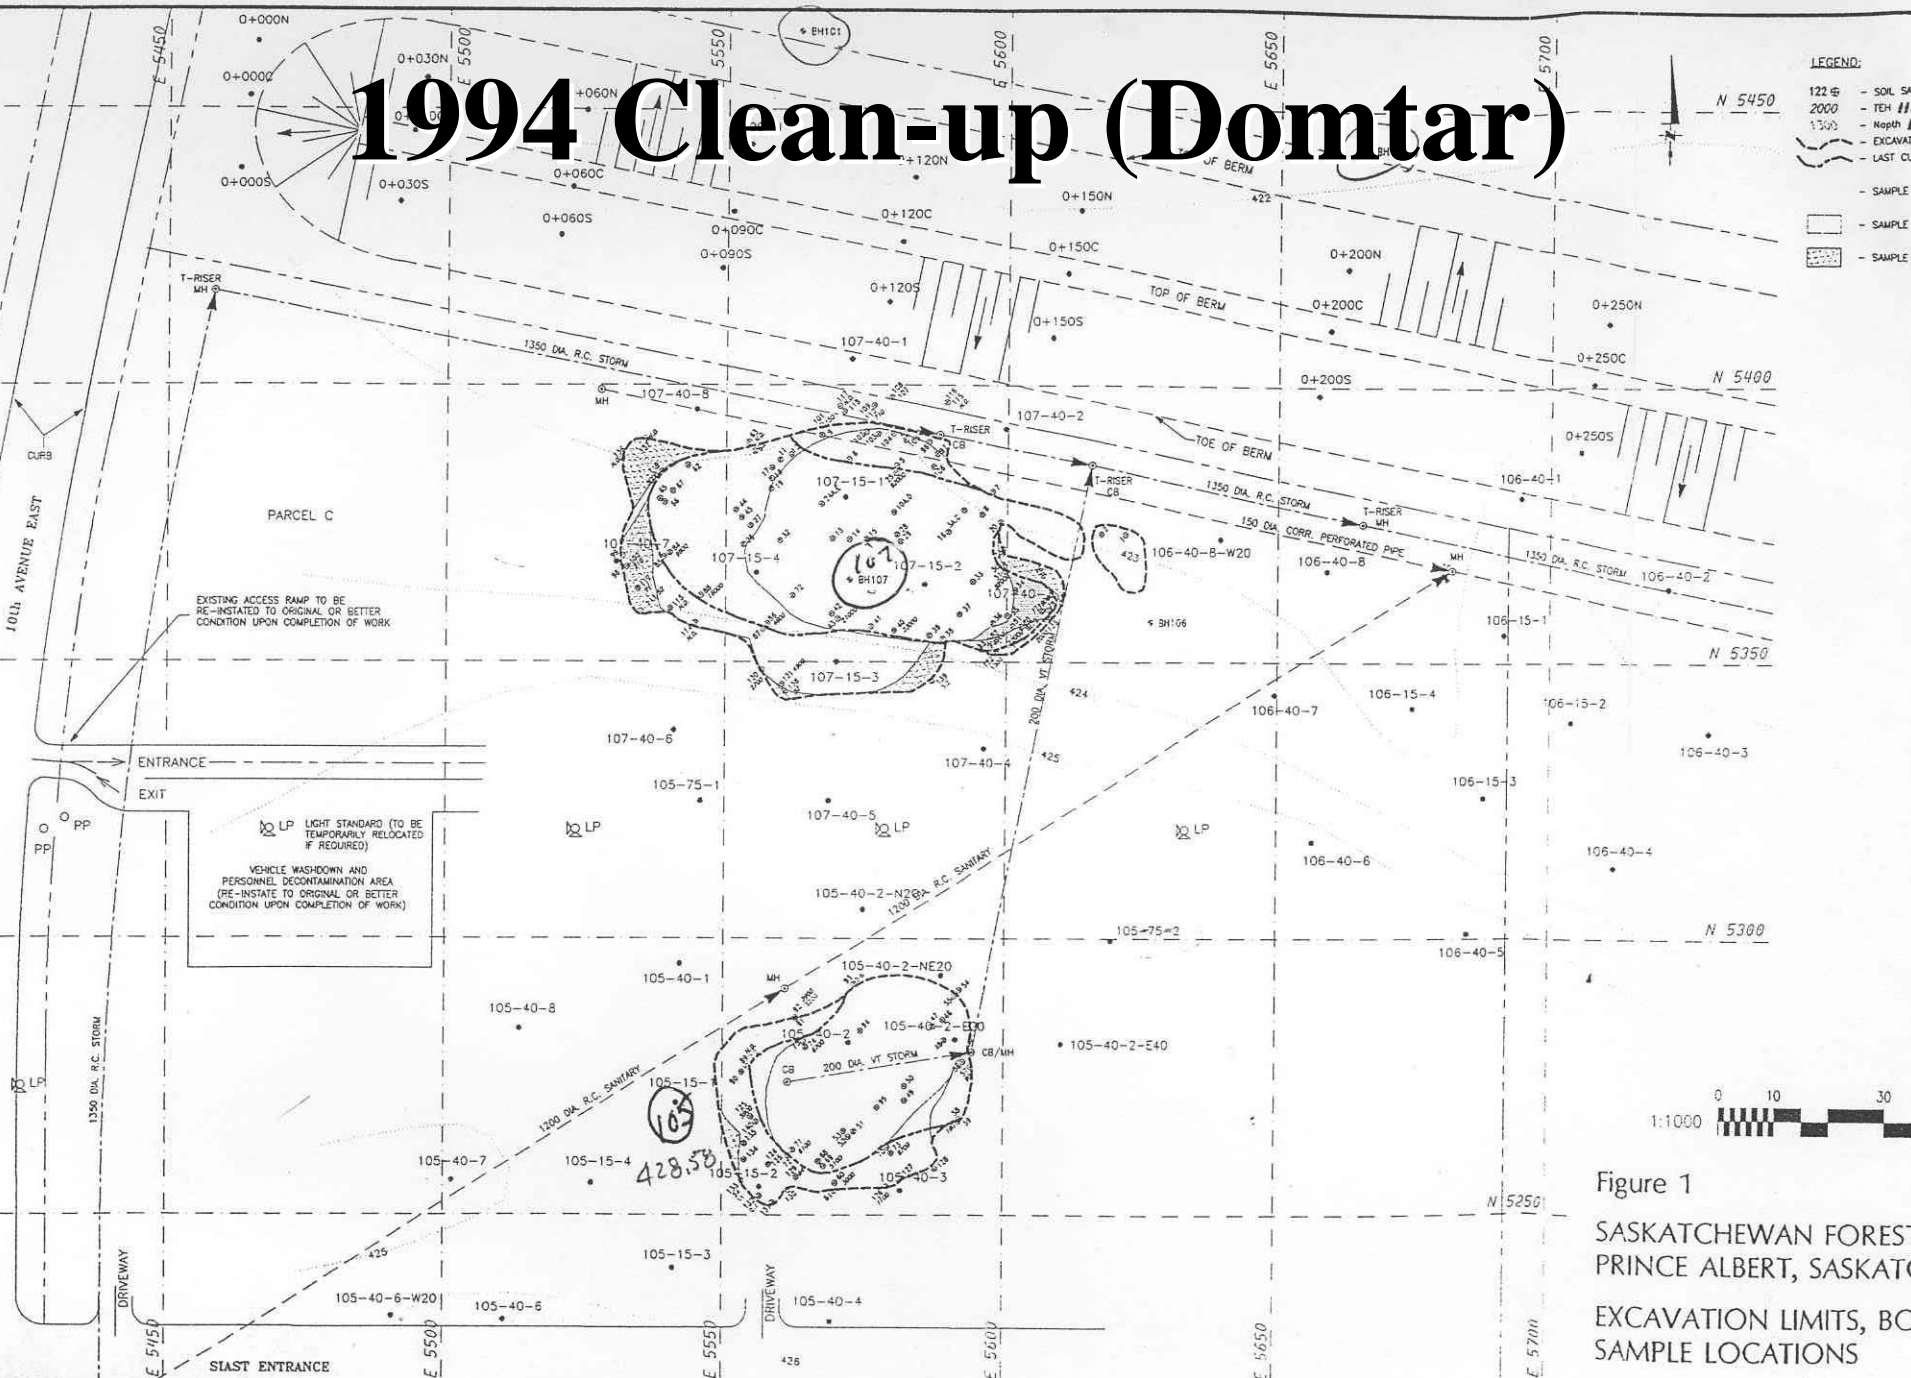
Figure 1  
SASKATCHEWAN FOREST  
PRINCE ALBERT, SASKAT  
EXCAVATION LIMITS, BO  
SAMPLE LOCATIONS

# 1994 Clean-up (Domtar)

EXISTING ACCESS RAMP TO BE RE-INSTATED TO ORIGINAL OR BETTER CONDITION UPON COMPLETION OF WORK

VEHICLE WASH-DOWN AND PERSONNEL DECONTAMINATION AREA (RE-INSTATE TO ORIGINAL OR BETTER CONDITION UPON COMPLETION OF WORK)

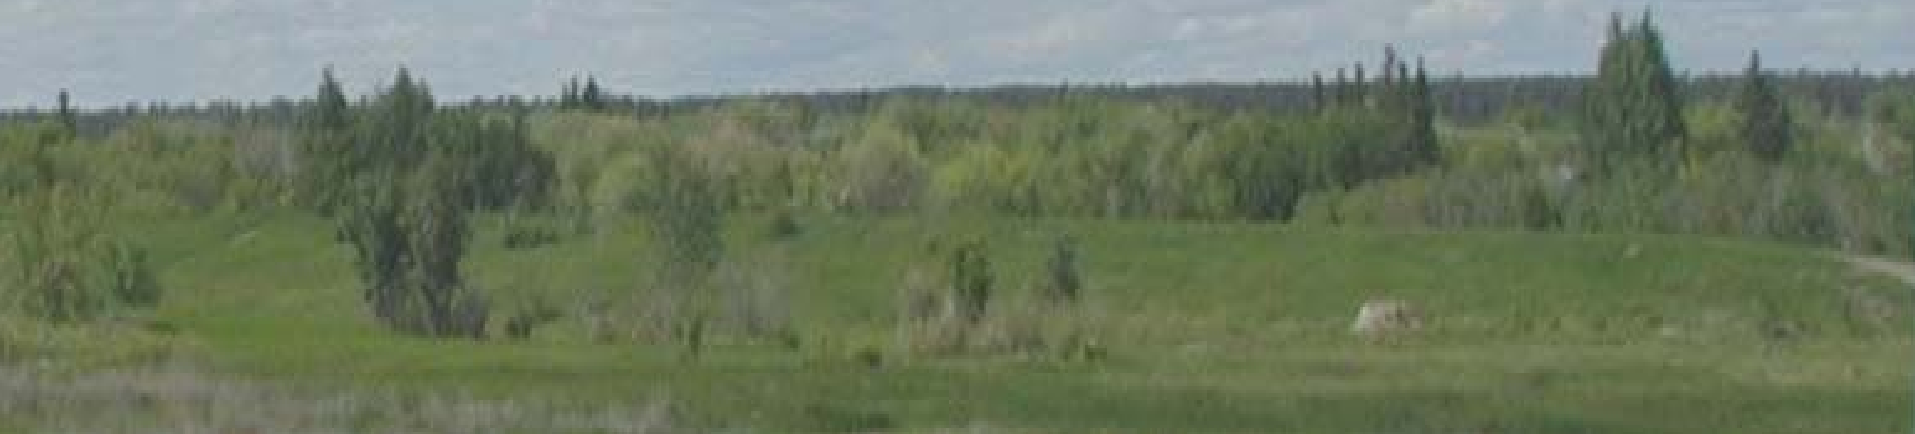
# As Things Were Left (1994)

- Due to budget and operational constraints, soils left in Exhibition Grounds' seasonal parking area were 10x CCME guideline. City believed the land-use would never change (managed risk).
